**REVESTIMENTOS COMPATÍVEIS PARA
ALVENARIAS ANTIGAS SUJEITAS A AÇÃO
SEVERA DA ÁGUA**

Tese elaborada no Laboratório Nacional de Engenharia Civil (LNEC) e apresentada à Universidade de Aveiro para cumprimento dos requisitos necessários à obtenção do grau de Doutor em Engenharia Civil, realizada sob a orientação científica da Doutora Engenheira Maria do Rosário da Silva Veiga, Investigadora Principal com Habilitação do Laboratório Nacional de Engenharia Civil e da Professora Doutora Ana Luísa Lomelino Velosa, Professora Associada do Departamento de Engenharia Civil da Universidade de Aveiro

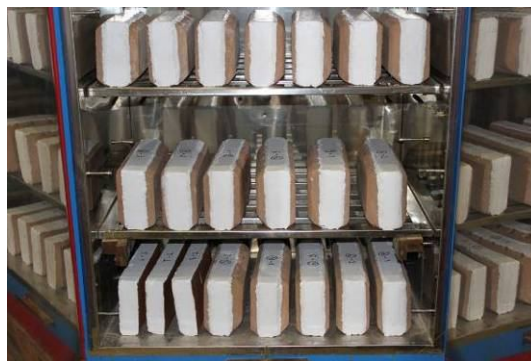
Fig. 6.16 Drying of specimens on the ventilated oven

In the second stage, the specimens were contaminated with NaCl solution (concentration 27g/l – similar to sea water content [Aug90]) in the same temperature and relative humidity conditions – by partial immersion to allow capillary rise through the specimens, reproducing in the laboratory, typical rising damp conditions, during several cycles (Fig. 6.15). Once they got constant weight, in each cycle, the specimens were dried. To speed up the drying they were left in a ventilated oven at 60°C during a week (Fig. 6.16) and then they were subjected again to partial immersion cycles in NaCl solution). In each cycle the wetting and drying phases were prolonged until constant mass of the specimens was attained. The test stopped when damage in the plaster was found or after 8 dissolution/crystallization cycles. The samples were not brushed between cycles.

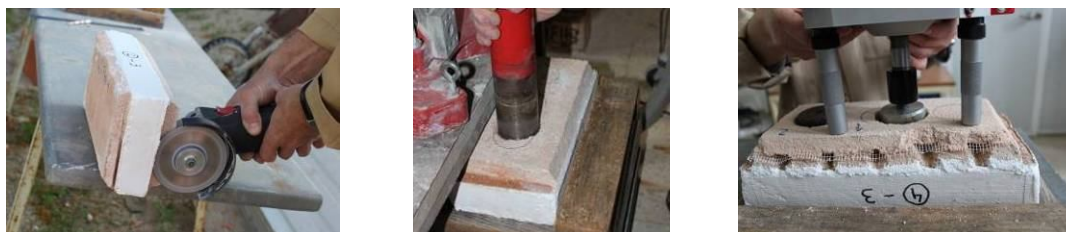
At the end of the 4th dissolution crystallization cycle, pull off tests were performed following EN – 1015-12:2000, to evaluate the type of rupture and if it happened between the outer layer of render systems and the base layer (FH7, FNH, FNH2 and FNH1 specimens) or between the render and the support (NH7 and NH1 specimens). Pull off tests were performed at the end of the 4th dissolution/crystallization cycle due to loss of cohesion of outer layer in almost all specimens observed since this stage, that made the execution of the test in a later stage more difficult. The tests were carefully executed and specimens had to be adapted; a wood base for their support (a especially developed structure) was designed to perform the tests on these singular specimens in order to allow the pull off tests without damaging the render system on the opposite side of the tested render (Fig. 6.17).

Fig. 6.17 Pull off tests on render systems: a) preparation of specimens (left) b) application of specimens in the wood structure for pull off tests (middle) and c) pull off test (right)

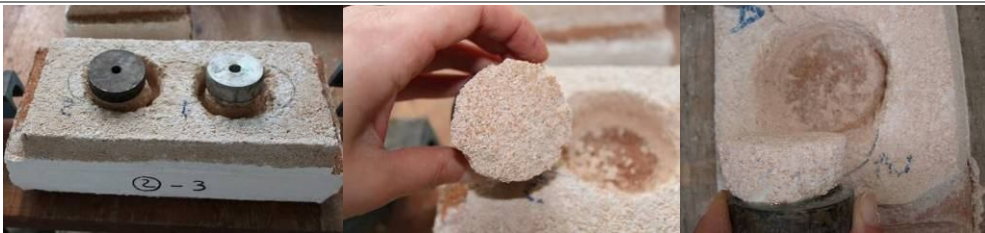
Specimen FH7			
Render system FH7	 		
	Evaluation: Adhesive rupture (rupture occurred between outer and base layer)		
Specimen NH7			
Render system NH7

Evaluation: Adhesive rupture (rupture occurred between render system and the support)		
Specimen FNH7			
Render system FNH7

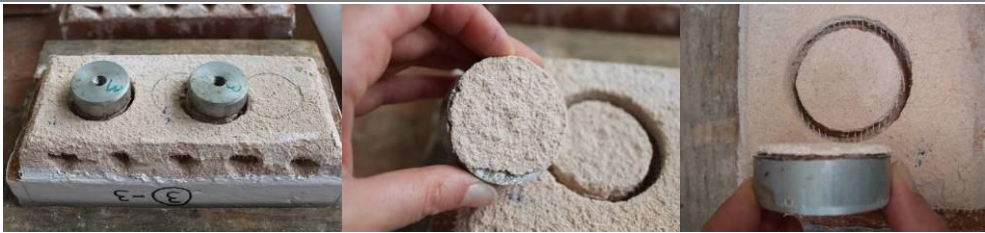
Evaluation: Cohesive rupture (rupture occurred in the outer layer)		
Specimen FNH2			
Render system FNH2

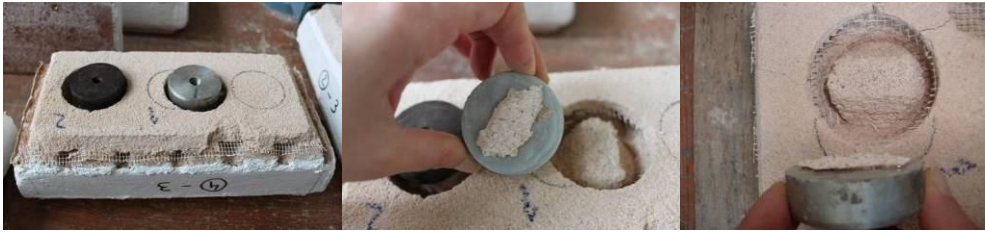
Evaluation: Adhesive rupture (rupture occurred between outer and base layer)		
Specimen FNH1			
Render system FNH1	 		
	Evaluation: Adhesive rupture (rupture occurred between outer and base layer)

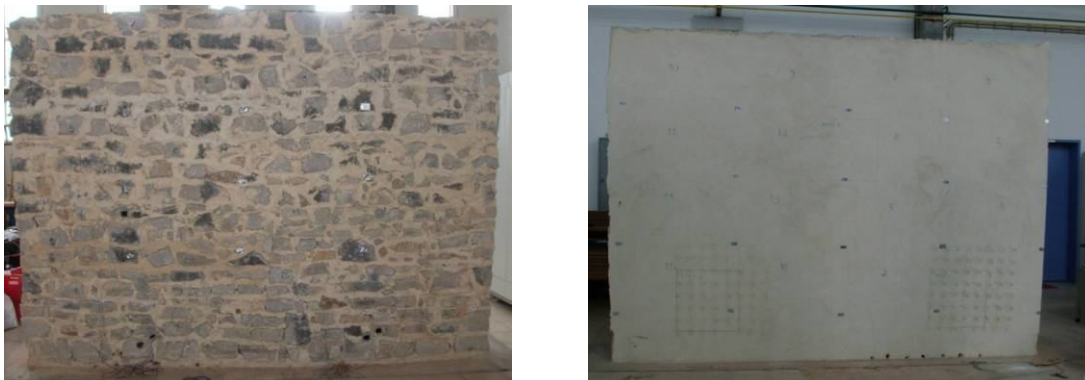
Fig. 7.2 Full-scale masonry wall – larger side A without render (before the tested render systems placement) (left); Full-scale masonry wall – larger side B with traditional lime render (right).

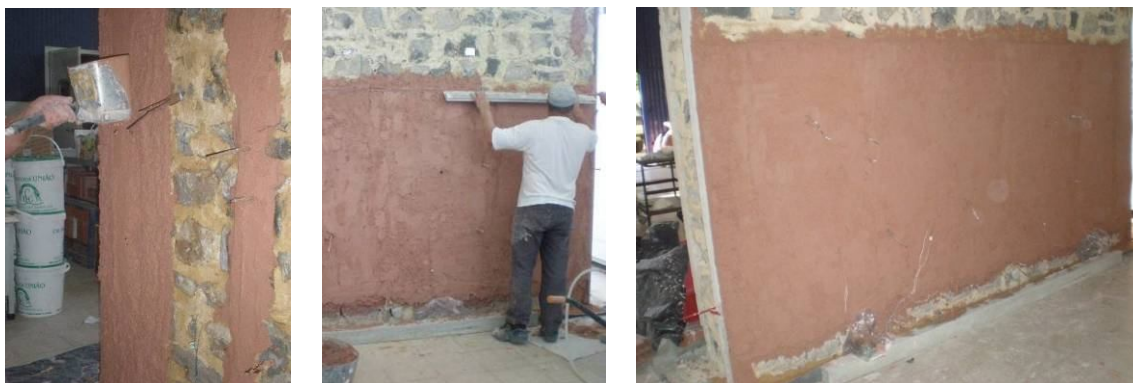
Fig. 7.3 Application of regularization mortar with render gun (left); Regularization of the support (middle); Final appearance of the masonry before base layer placement (right)

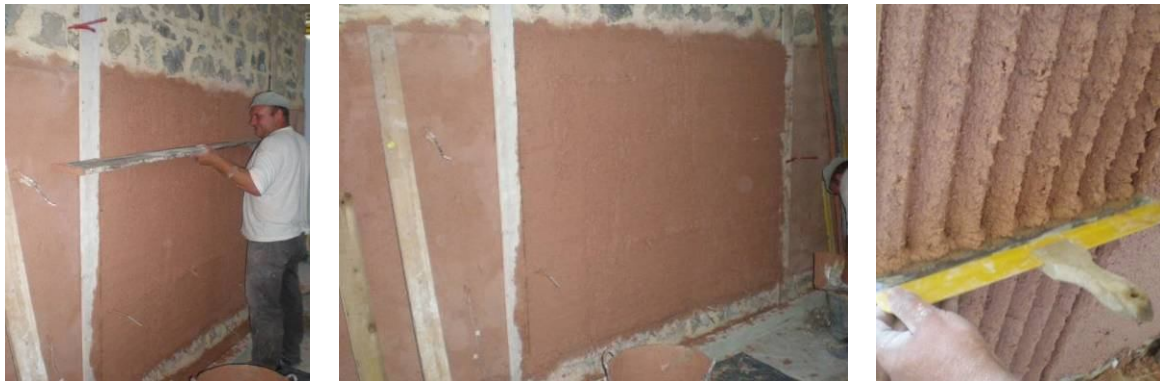
After this first phase, the base layer (pre-dosed F7 render) was executed with about 2 cm thickness (Fig. 7.4). This base layer was divided into four panels with the same width, in which the four render systems were applied. The render systems named FH7, H, NH, FNH7 were applied, respectively, from left to right (Figure 7.7). Grooves were executed in the base layer in the panels corresponding to render systems FH7 and FNH7. In the two panels of the middle, H and NH render systems, no grooves were executed. The bottom and top of the grooves were exposed to outside air allowing circulation of air within the grooves.

Fig. 7.4 Execution of base layer - F7 render (left); Final appearance of base layer of render systems H and NH (middle); Execution of vertical grooves in base layer of render systems FH7 and FNH7 (left).

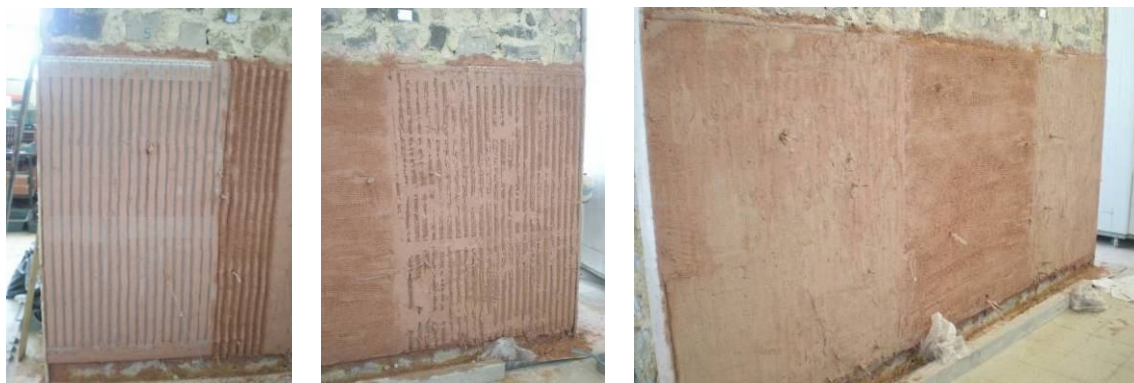
After executing the grooves in panels FH7 and FNH7 a glassfibre mesh (2 mm x 2 mm) was applied to avoid filling the grooves and enable the adherence between base and outer layer. A mortar composed by lime putty and fine sand was used to close the glassfibre mesh. In Fig. 7.5 is the final aspect of the base layer of all render systems.

Fig. 7.5 Grid applied above the vertical grooves in base layer of render systems FH7 and FNH7 (left); Mortar used to close the grid (middle); Final appearance of base layer in all render systems (right).

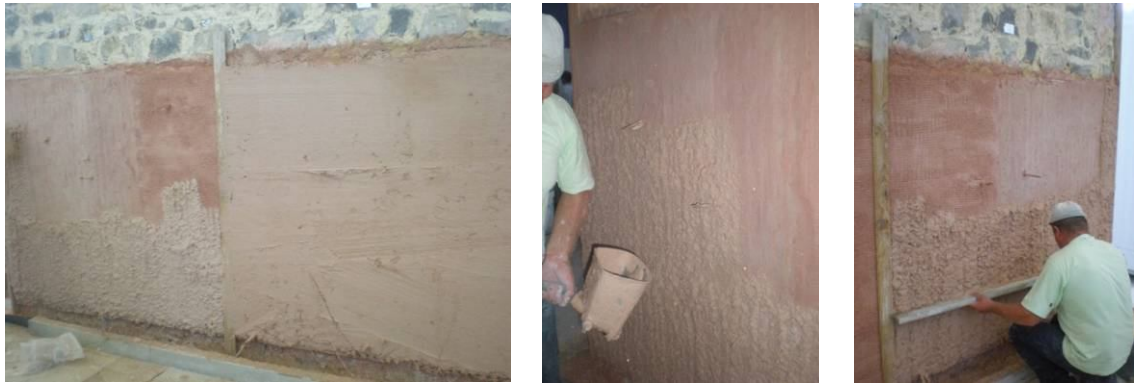
The outer layer of the two panels of the left was executed with F1h formulation (with water repellent additive in the putty) and the two of the right with F1 (without water repellent additive in the putty) render (Fig. 7.6). This layer was executed with 1 cm thickness. The excess of material was removed using a wood float, which results in an open texture on the render surface.

Fig. 7.6 Execution of outer layer with water repellent in render systems FH7 and H (left); Use of render gun for render systems execution of the outer layer (middle); Execution of outer layer without water repellent in render systems NH and FNH7 (right).

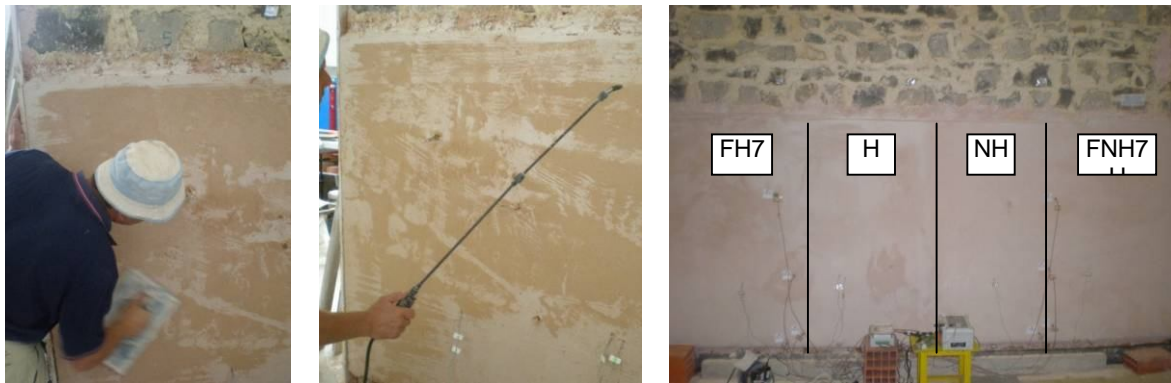
Fig. 7.7 Plastic trowel used to consolidate the outer layer (left); Spraying of the outer layer with water (middle); Final appearance of the render systems FH7, H, NH and FNH7 (right).

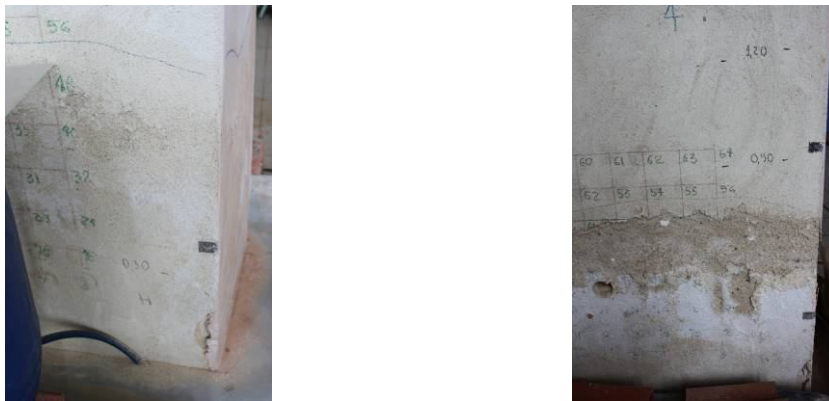
Fig. 7.22 Damage observation on the traditional lime render on the full-scale masonry wall: a) after 1 month drying on 2nd cycle (left); after 6 months drying on 3rd cycle (right).

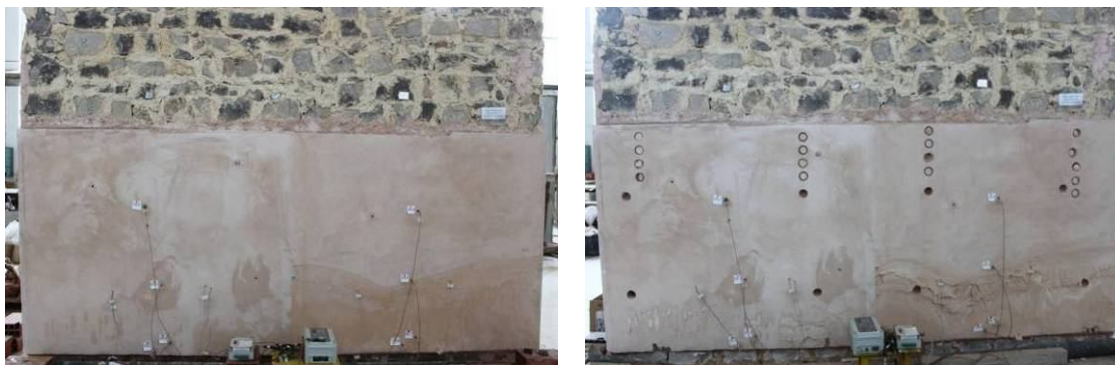
Fig. 7.23 Damage observation on render systems FH7, H, NH and FNH7 on the full-scale masonry wall: a) after 1 month drying on 2nd cycle; b) after 6 months drying on 3rd cycle

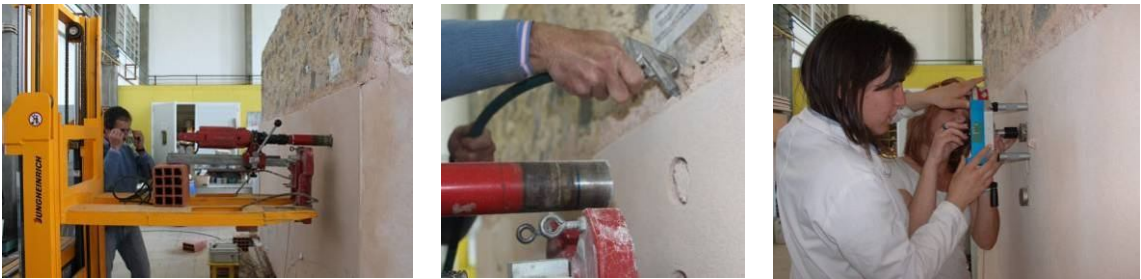
Fig. 7.24 Pull-off tests on render systems: a) equipment adaptation (left), b) careful execution of circular tears (middle) and, c) pull off test (right).
